Tilcon New York, Inc.  
Clinton Point Quarry

# Water Infiltration Mitigation Project

Gregory H. Sovas, P.E.  
Spectra Environmental Group, Inc.

New York State DEC  
Mined Land Rec. Conference  
Syracuse, New York  
March, 2007

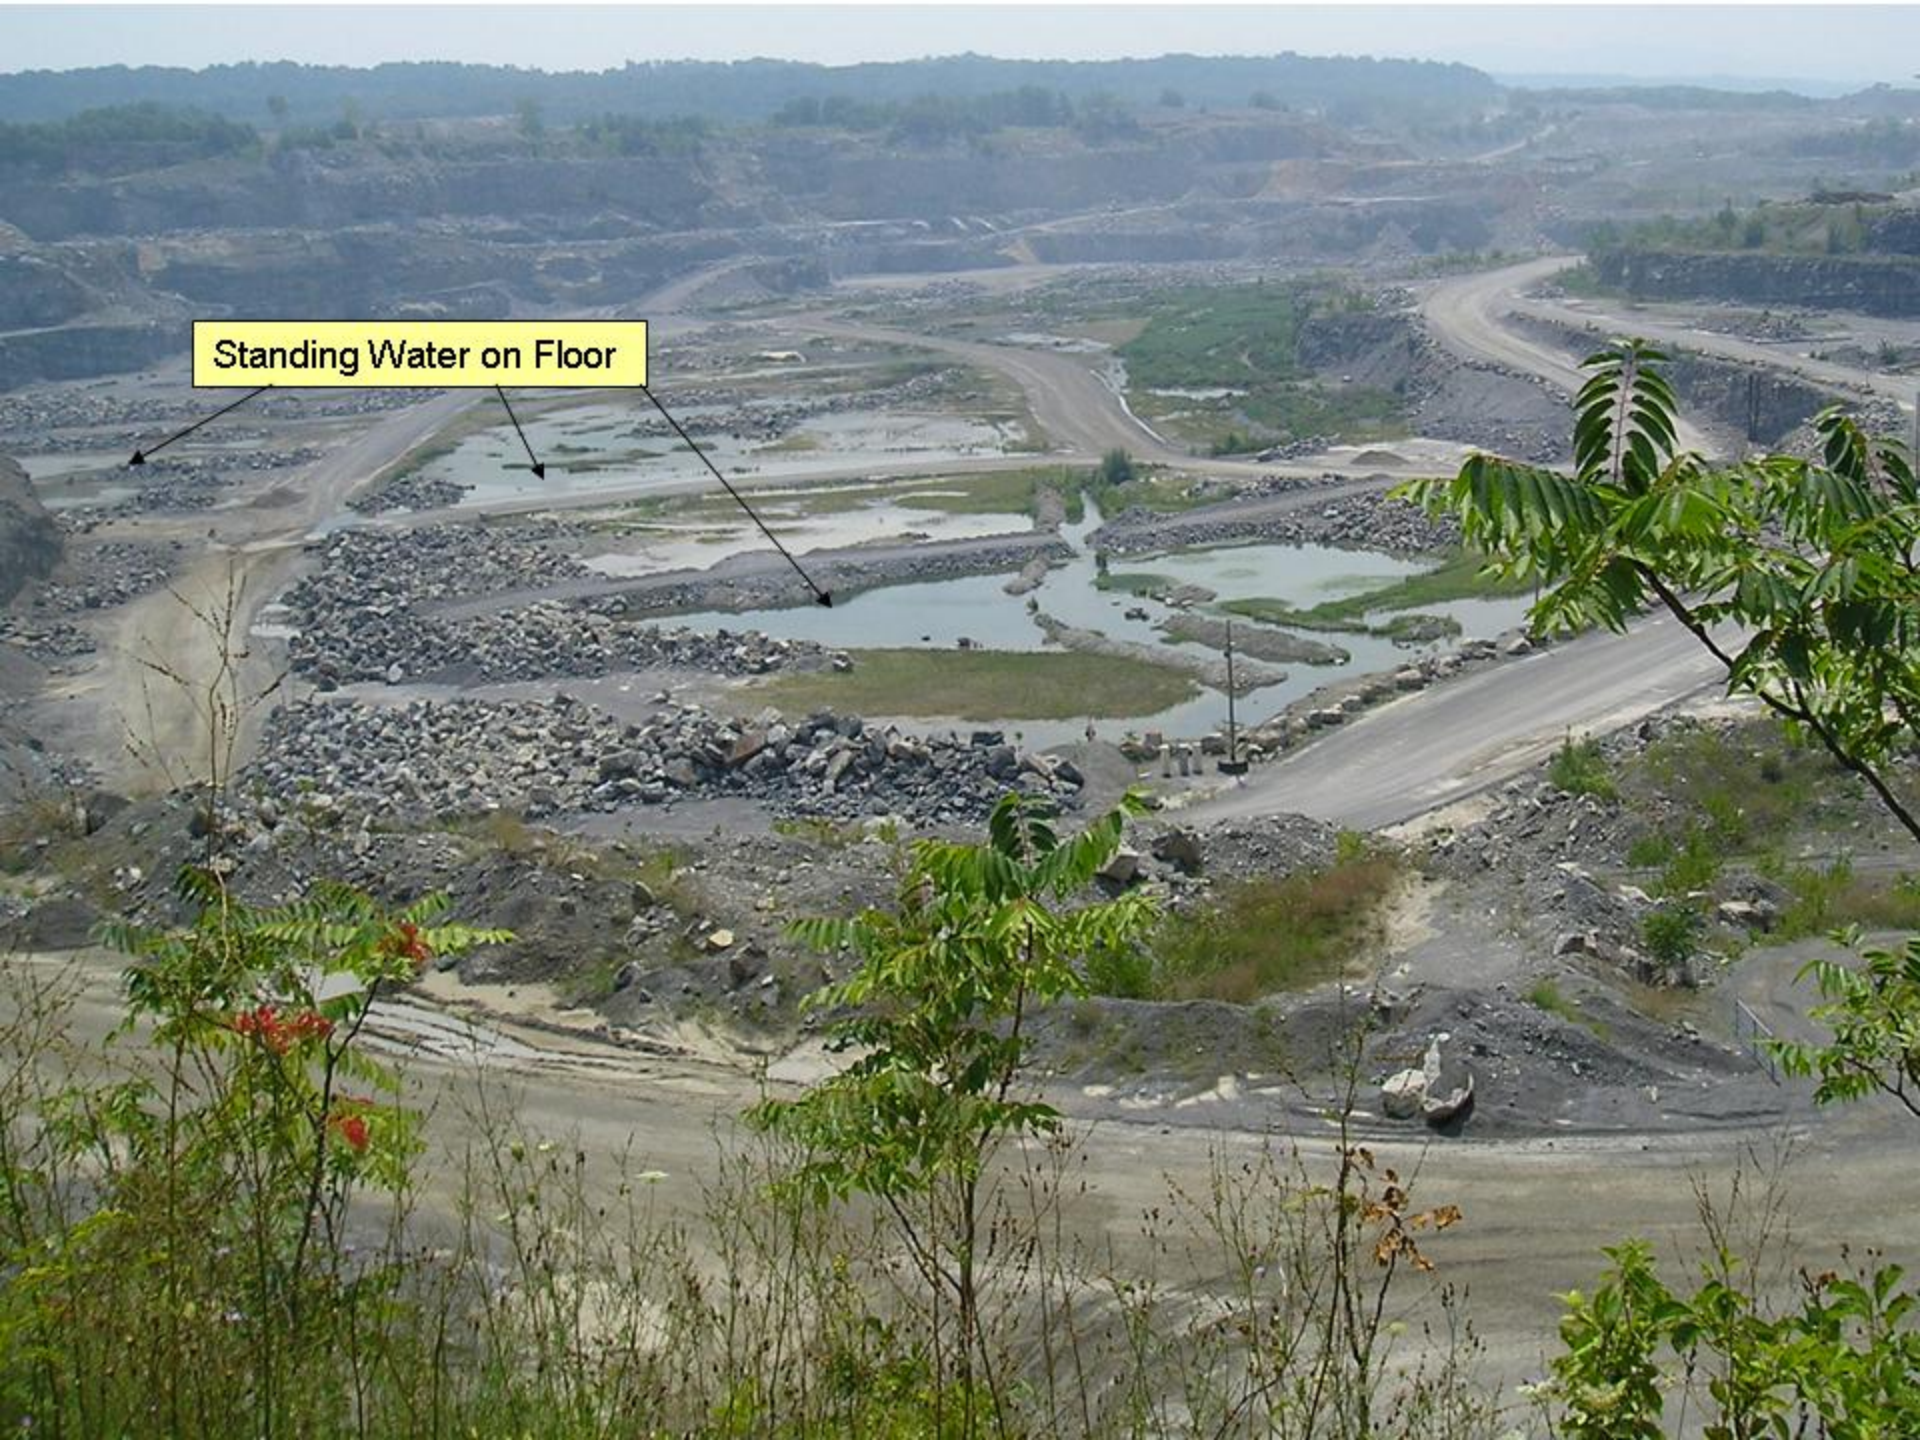
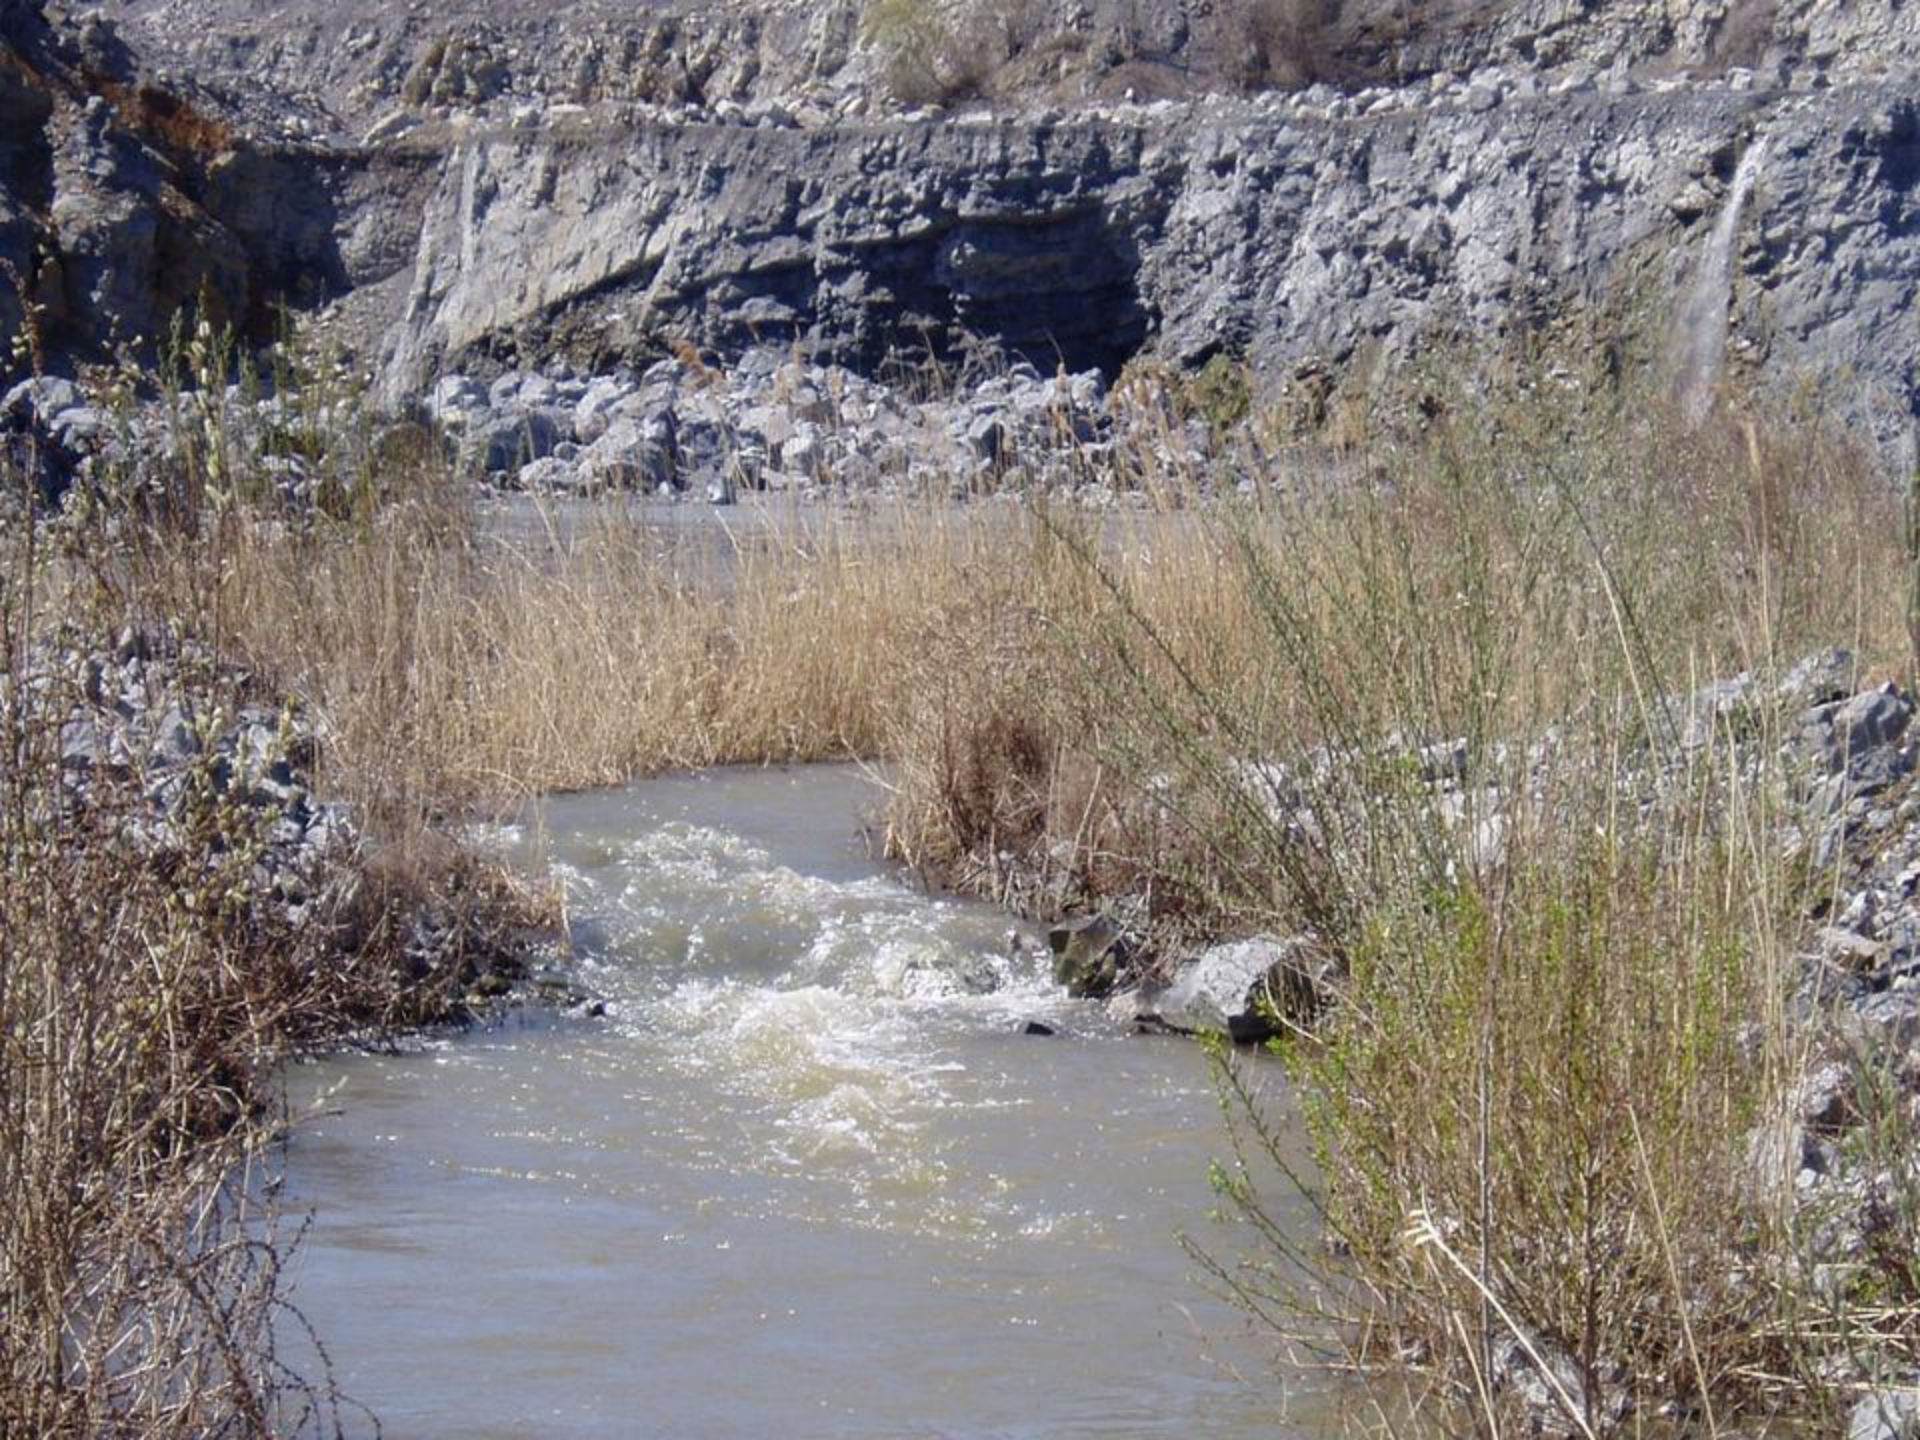
Standing Water on Floor

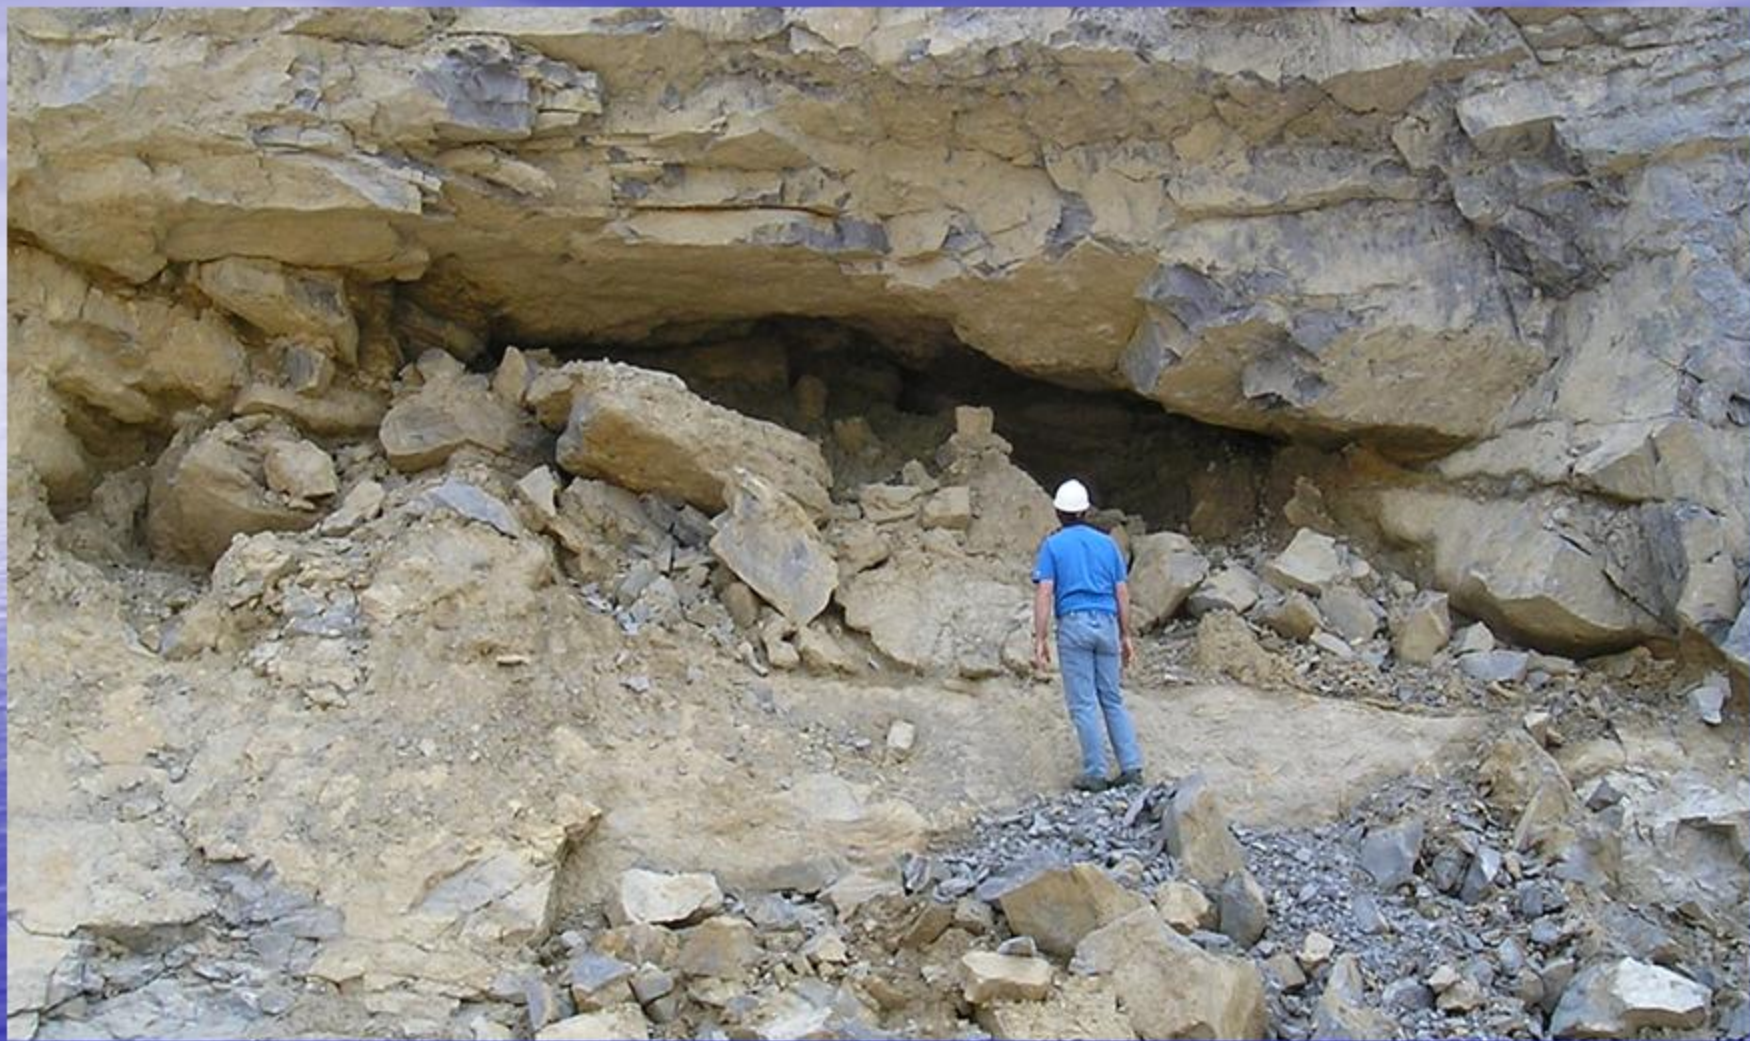
**Large Karst Feature - East wall of quarry. Infiltration pathway?**

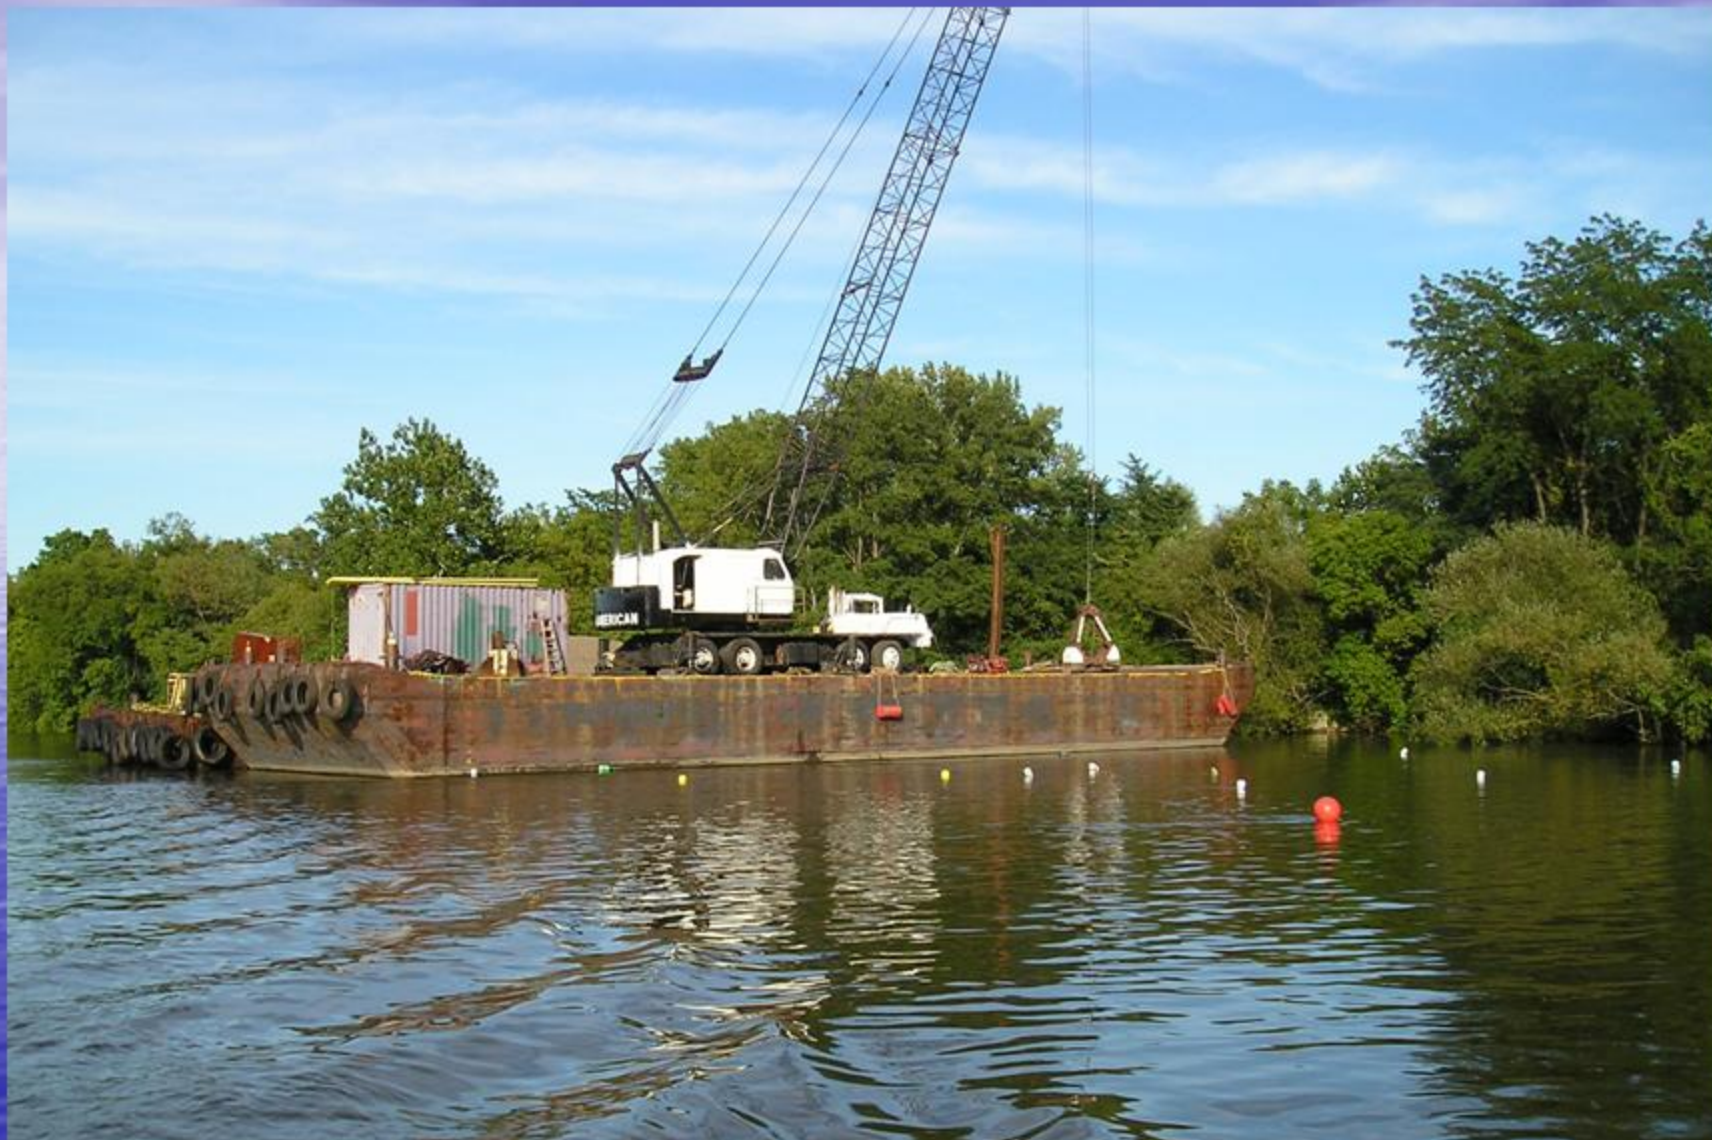
# Buoys Mark Infiltration Points

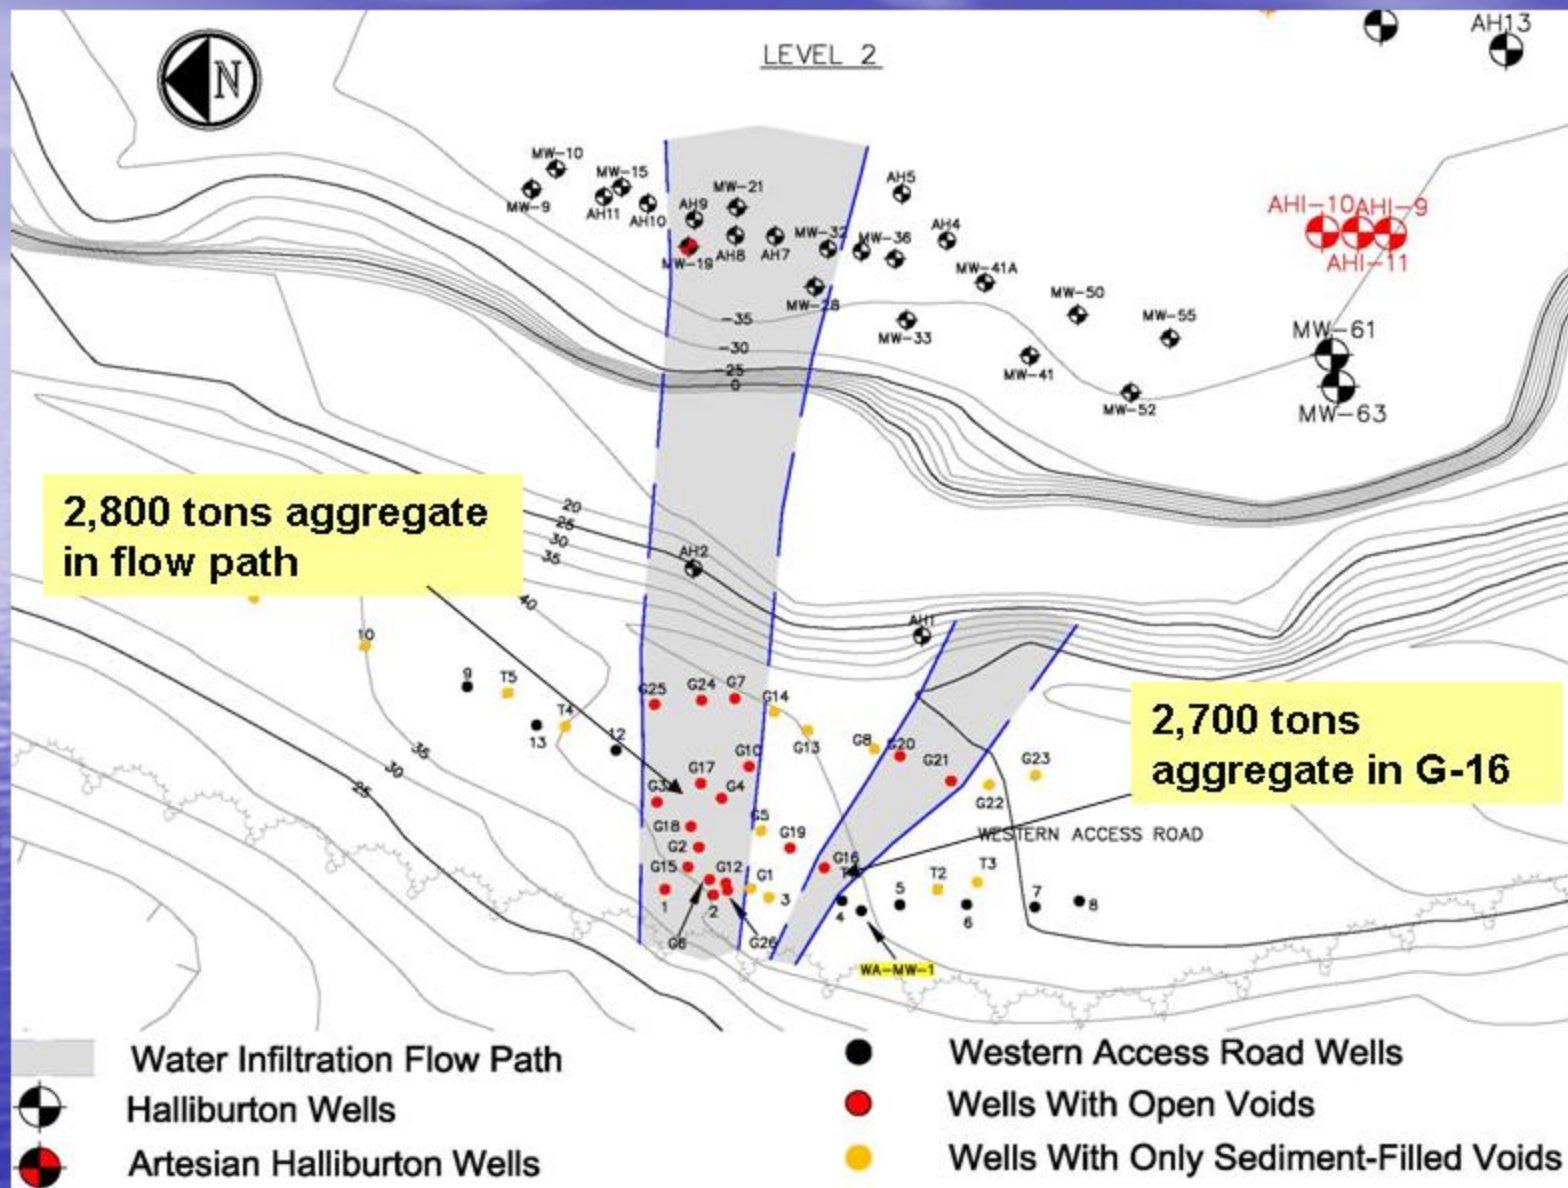
# Water Infiltration Flow Paths

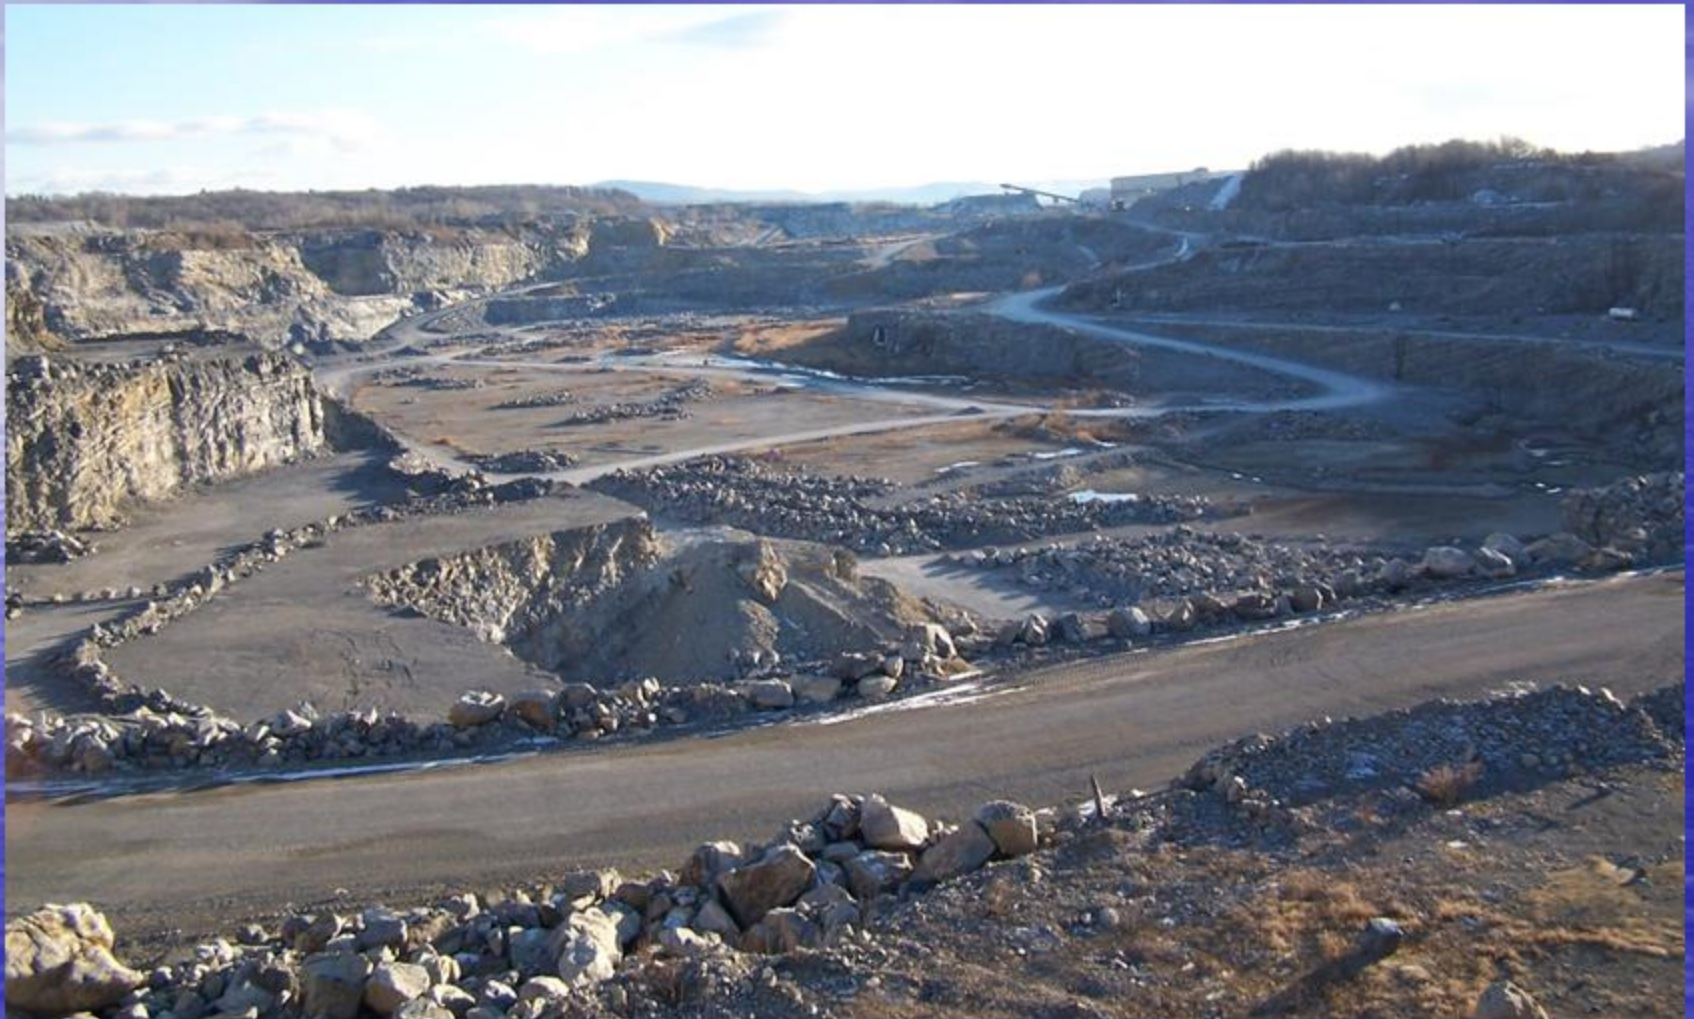
A DRY QUARRY FLOOR!
