Tilcon New York, Inc.  
Clinton Point Quarry

# Water Infiltration Mitigation Project

Gregory H. Sovas, P.E.  
Spectra Environmental Group, Inc.

New York State DEC  
Mined Land Rec. Conference  
Syracuse, New York  
March, 2007

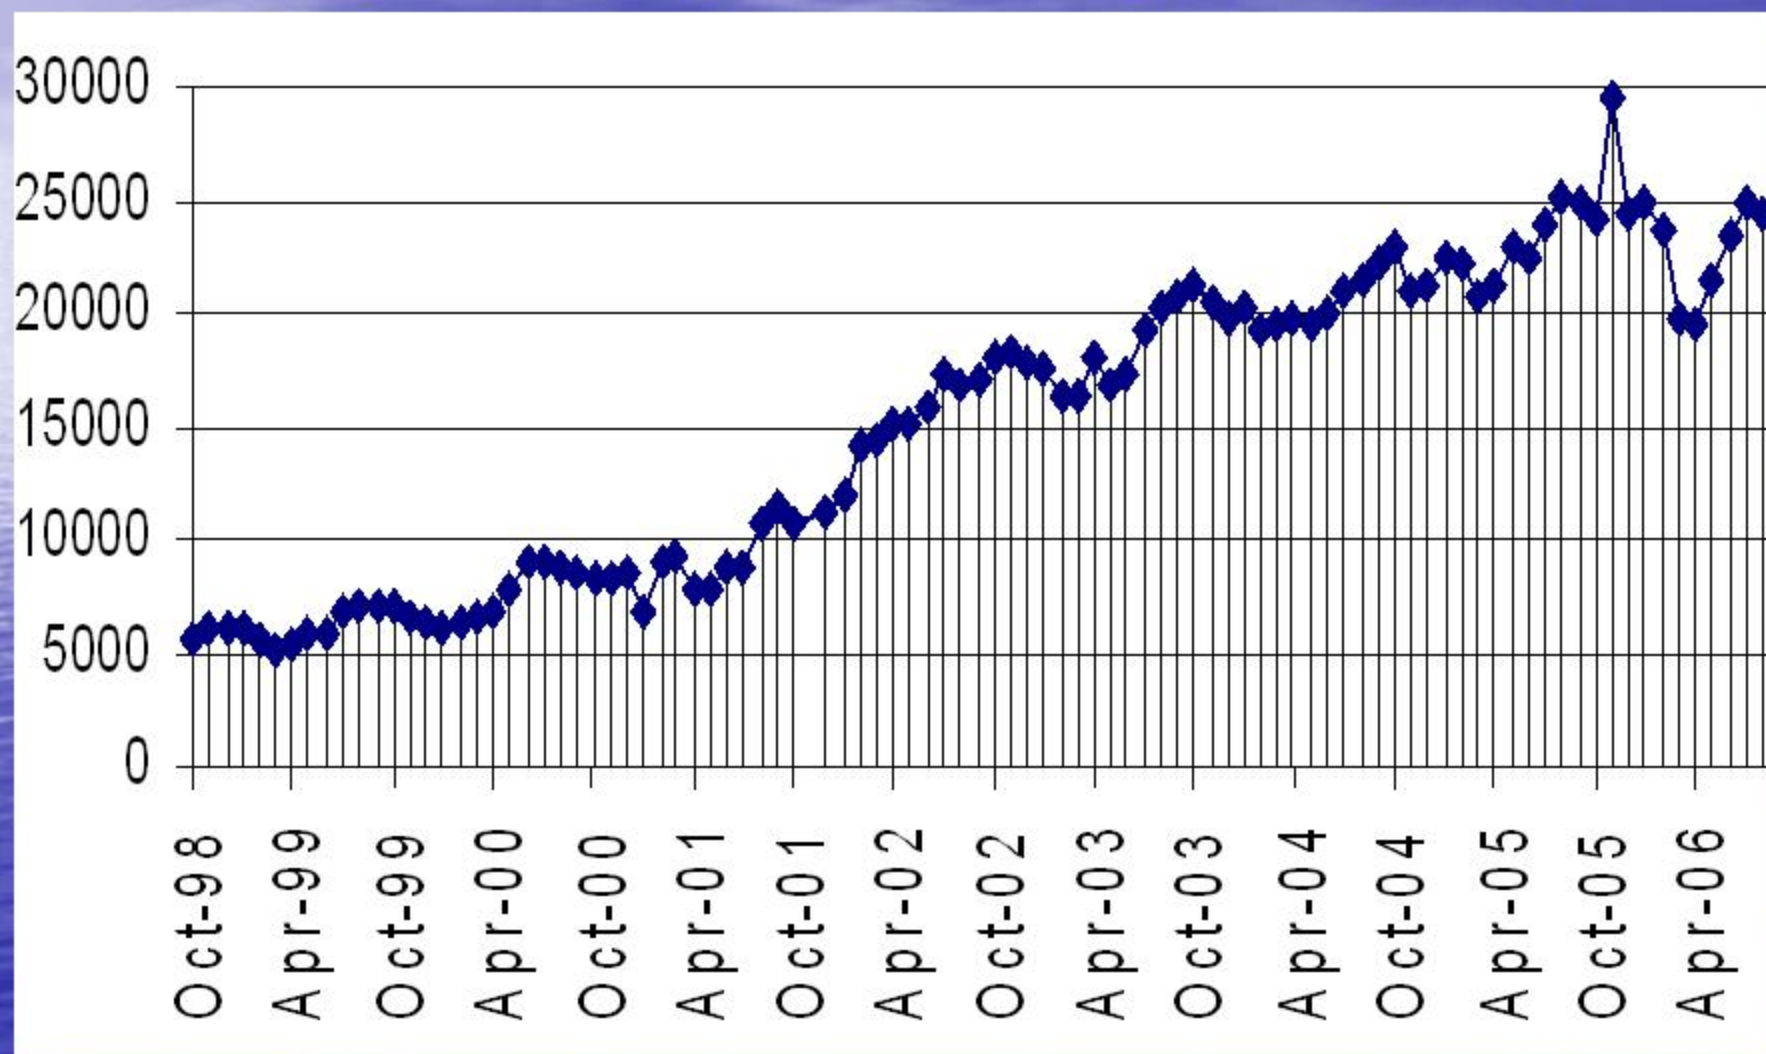
## Average Monthly Dewatering Rate (GPM)

Standing Water on Floor

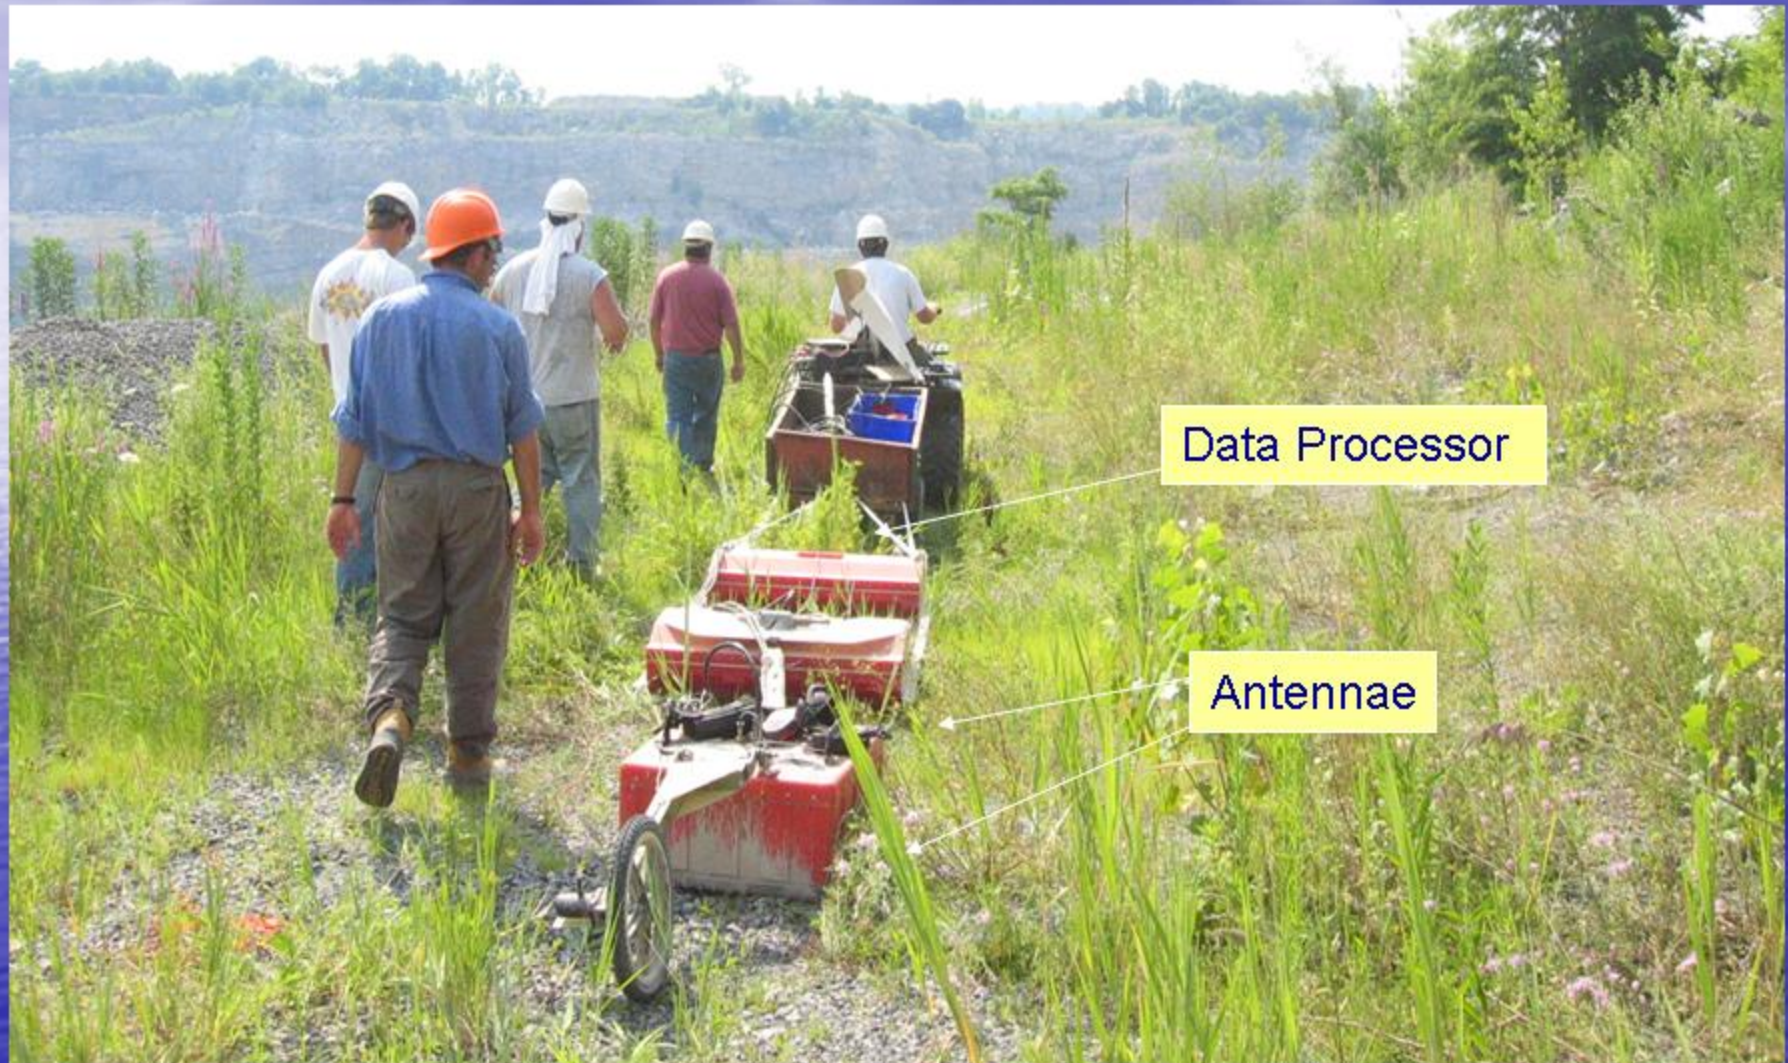
# Geologic Investigation - GPR SURVEY

## Identified Features of Interest in the Subsurface

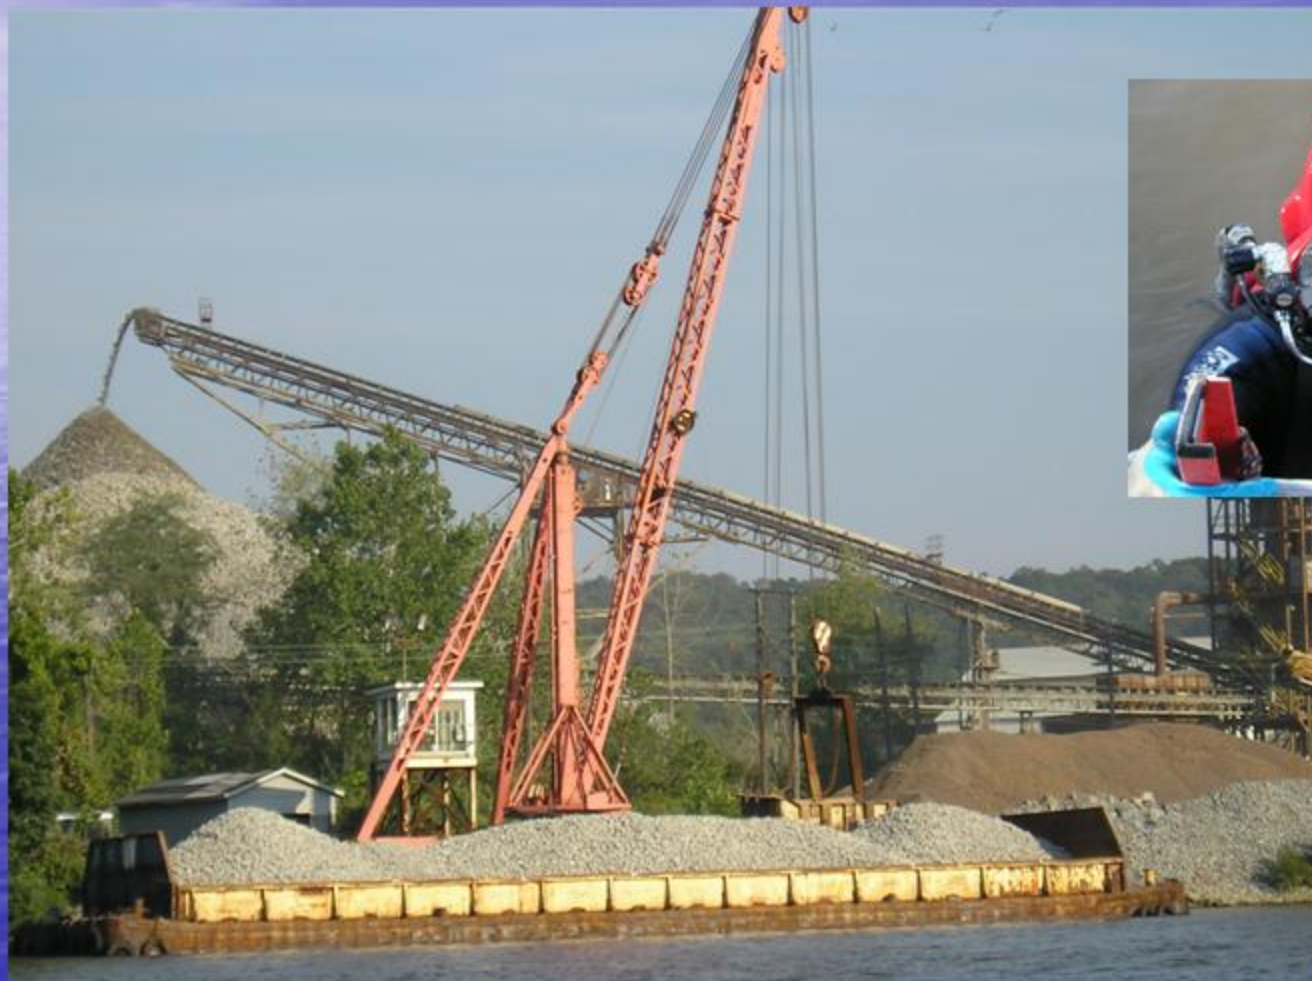
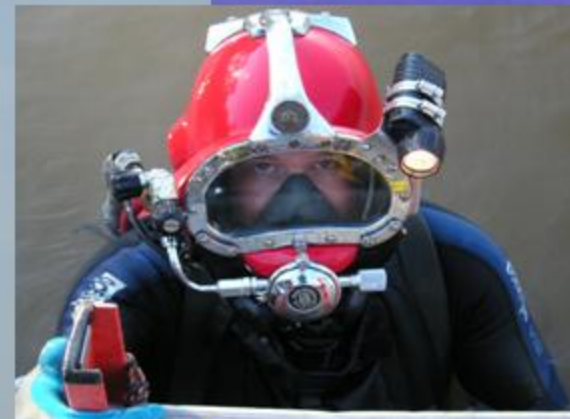
# Phase I – River-based Remedial Repair Summary

- Target zone reconnaissance – locate and mark all holes
- Placed 2,800 tons of lightweight aggregate
- 10,000 sq. feet of geomembrane
- Three to four feet of mixed aggregate blanket over geomembrane
- 40% initial reduction in infiltration volume

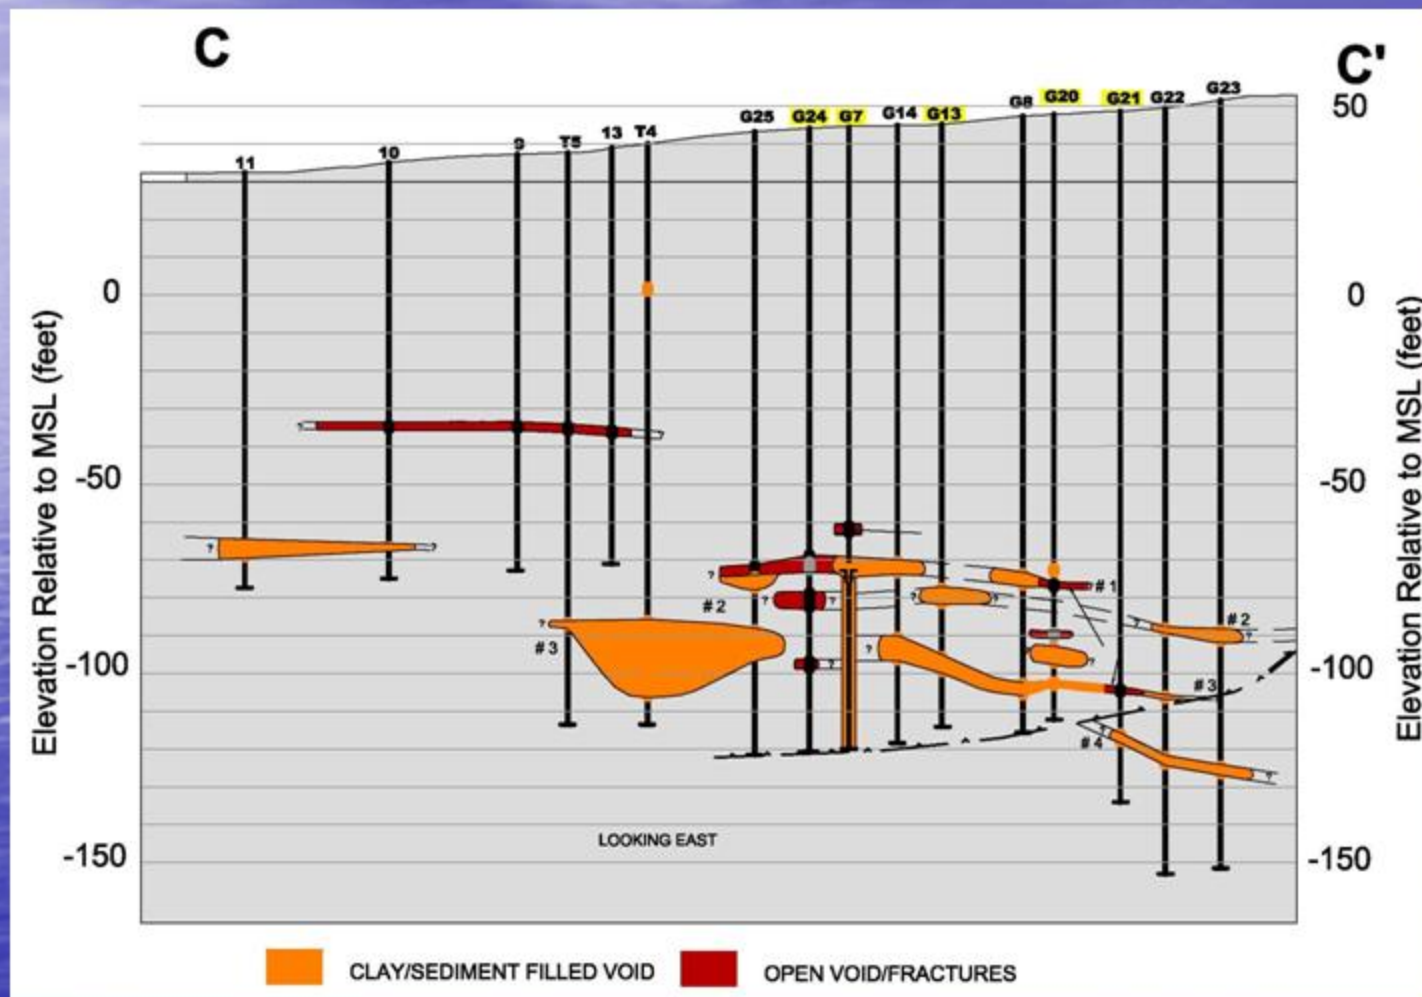
## Relationship of Open and Sediment-Filled Voids

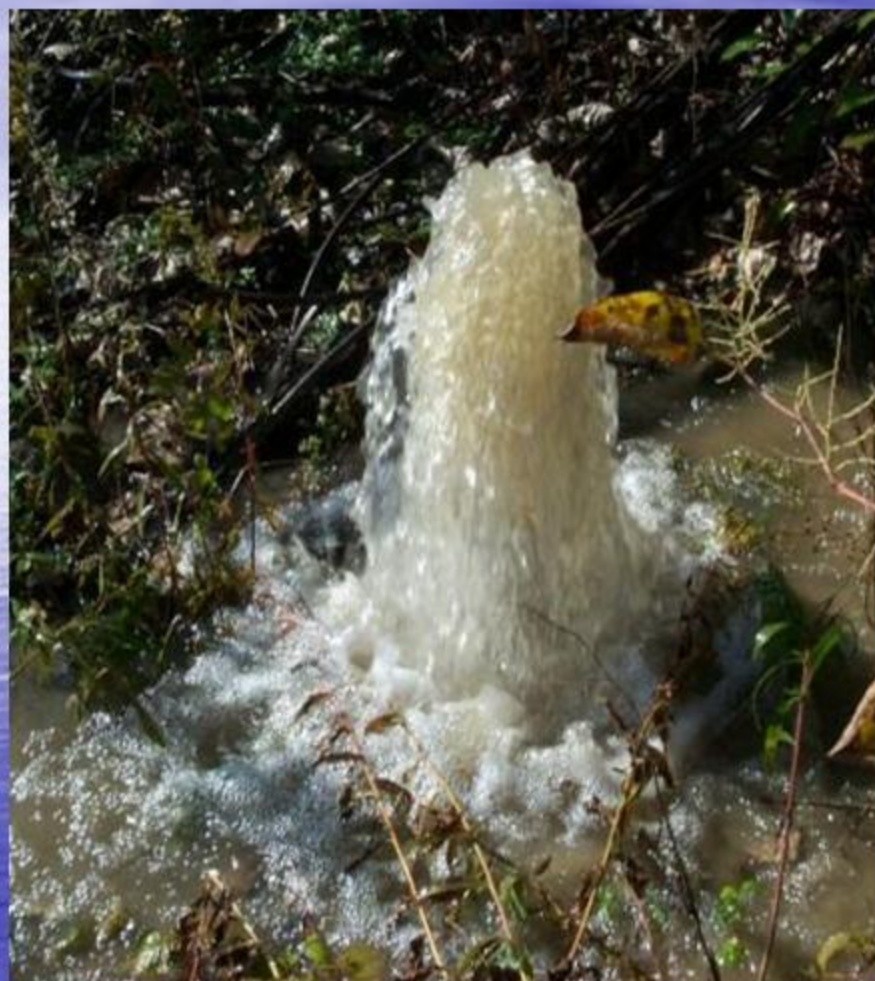
Groundwater response to grout injection

- 31 wells drilled for grouting
- Larger karst zones than anticipated
- Identified three distinct karst zones separated vertically
- Two distinct infiltration flow paths
- 17 wells grouted
- 5,500 tons of sized aggregate
- 133,000 pounds of urethane grout

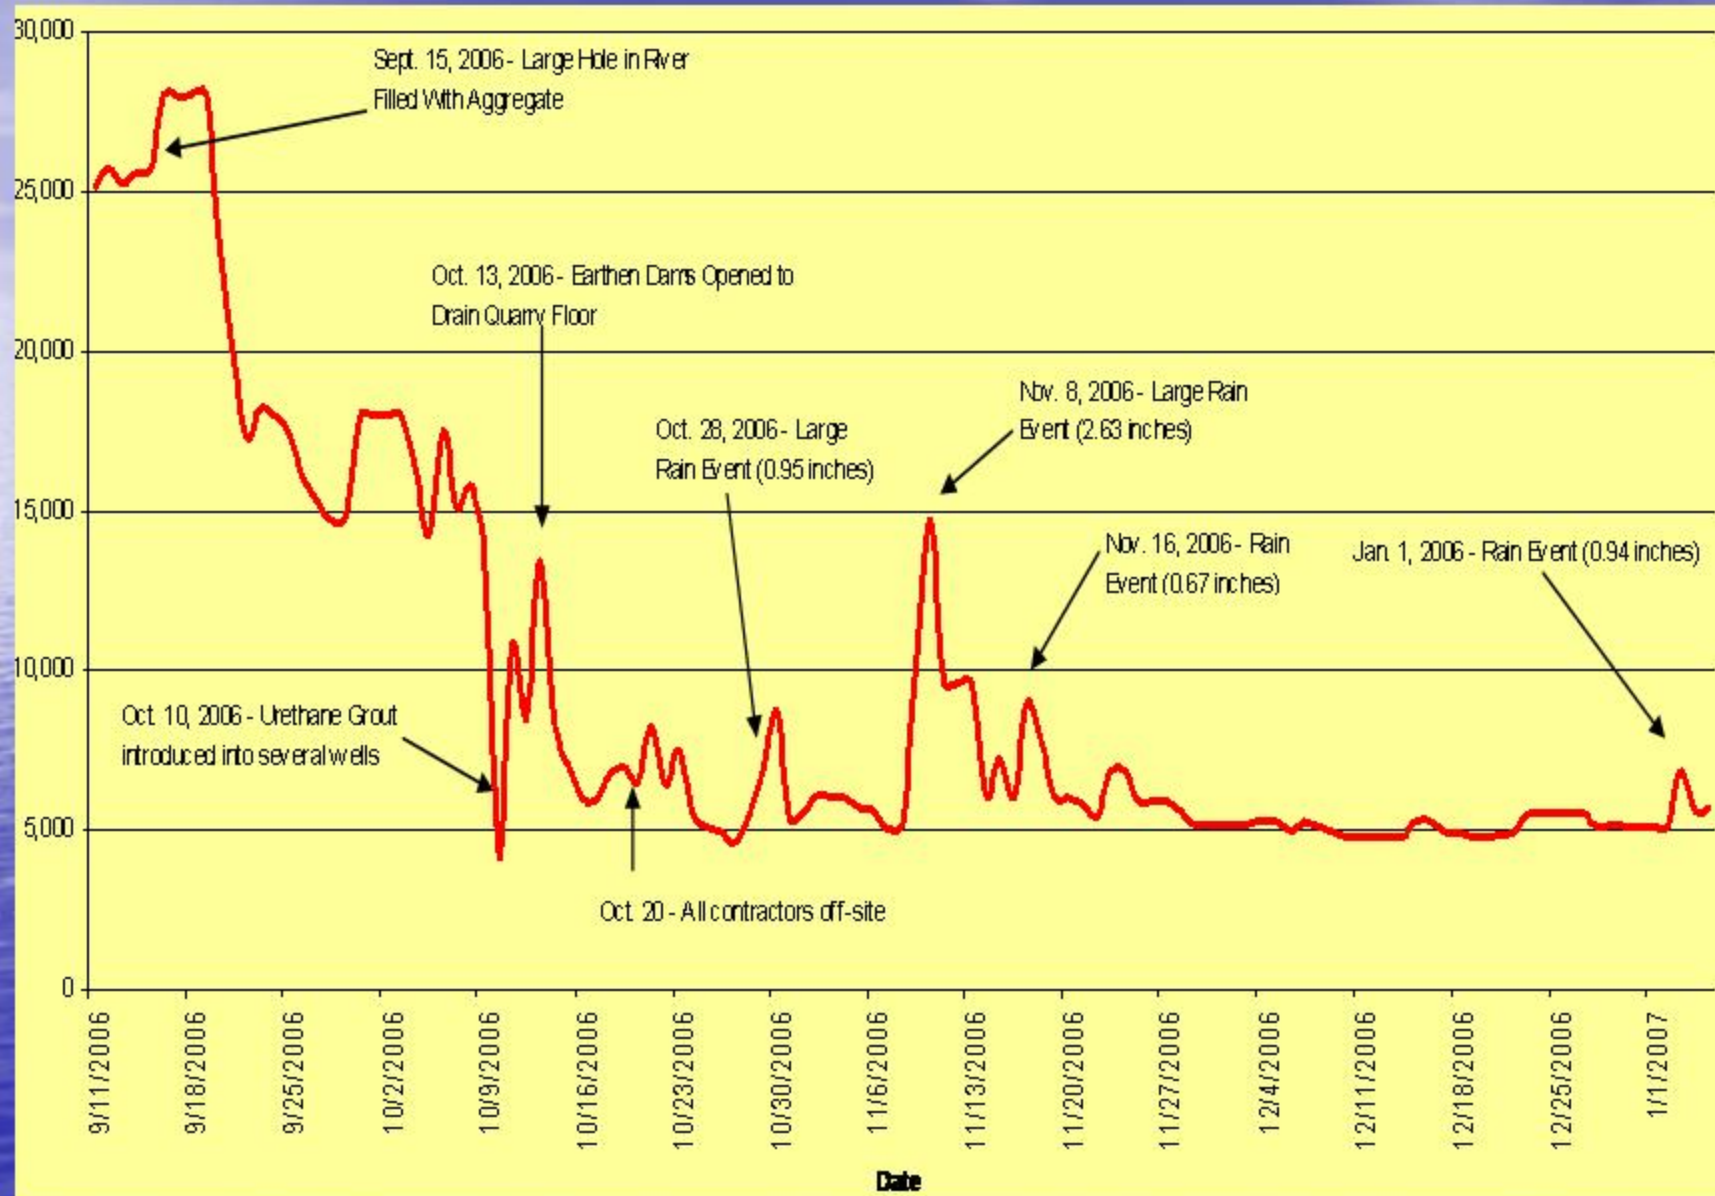
- Dewatering Discharge Rate Reduced to 5,000 gpm
- One Pump Cycling – approx. 20.5 hour/day
- Four Pumps Off-Line
- No standing Water on Quarry Floor
- Precipitation Events Managed More Quickly
- Greater Access to Quarry Floor

# Average Daily Discharge Rate (GPM)
